Montgomery County Fire and Rescue Service

POST INCIDENT ANALYSIS

Major Medical & Technical Rescue Incident Montgomery Mall

Incident Date: May 23rd 2013

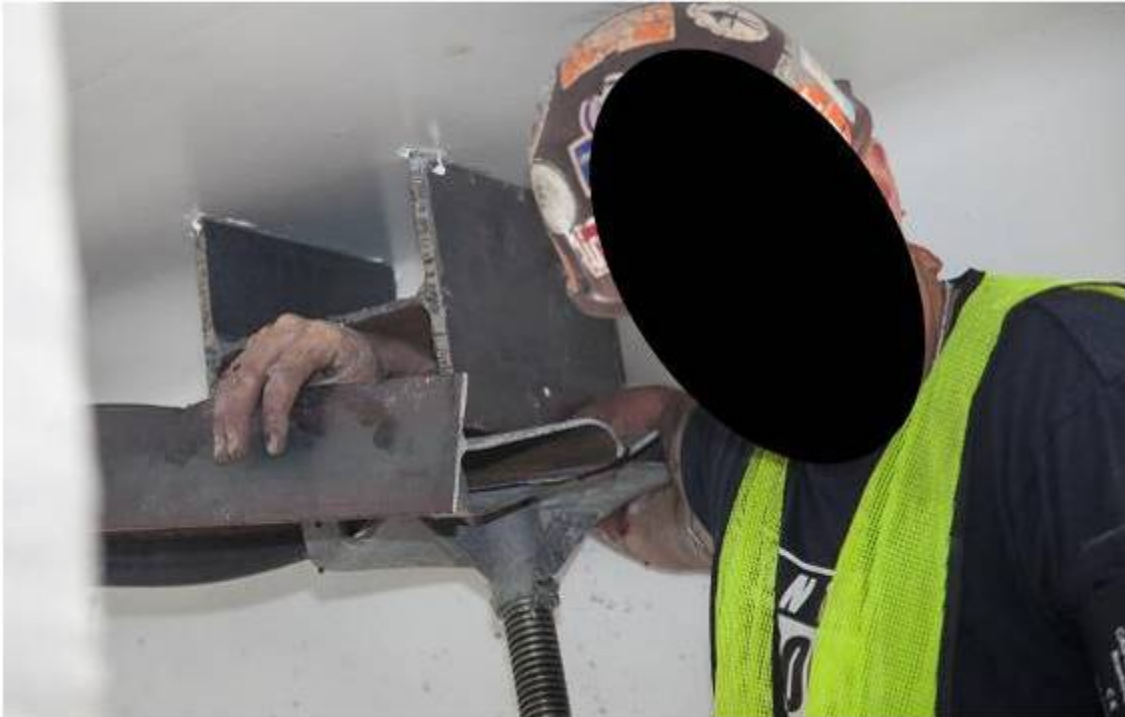
The entrapment of the victim consisted of his upper arm pinched/pinned between two steel I-beams that were bearing weight of the double T between the two "t's". The I-beams were supported on top of the H-frame pipe scaffolding that was being used to support the double T move.

Figure 1 Patient Entrapment Condition

After developing several extrication plans and in discussion with the Go-Team personnel, the extrication consisted of cutting the H-frame pipe scaffolding in the thread segment with a grinder. This allowed the support base, similar to a “U” channel to allow the I-beams to be lowered and the patient freed.

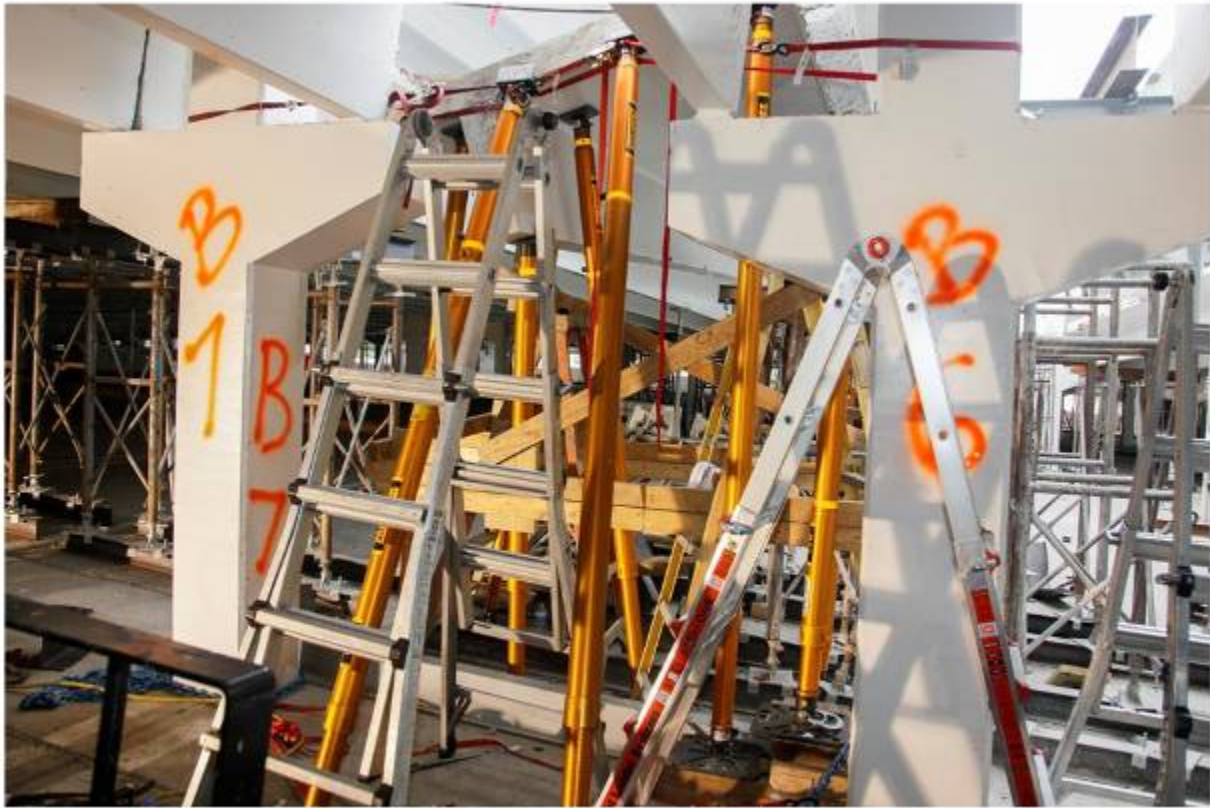
Initial shoring consisted of pneumatic rescue shoring, from Rescue Squads 741 and 703, being placed as an immediate spot shore with diagonal strap tie backs. This was then expanded by additional pneumatic rescue struts with raker braces and cross braces from the MD-TF1 cache.

Figure 2 Shoring Overview

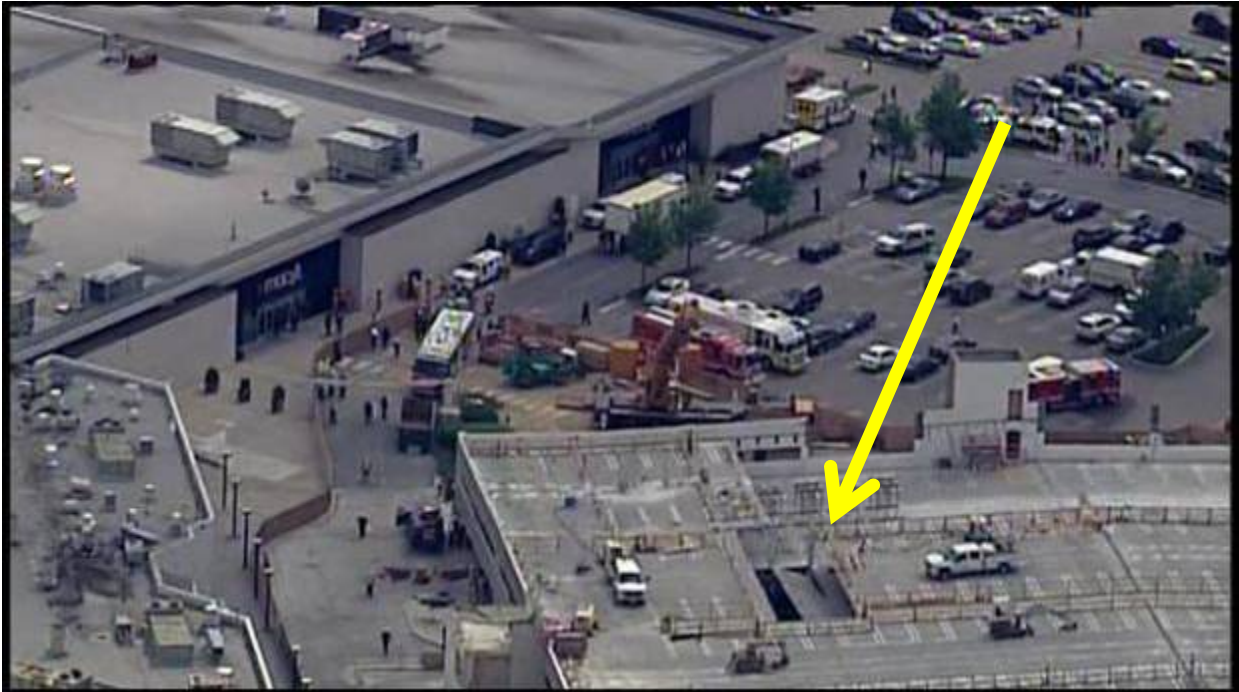
Figure 4 Area of Collapse from the Charlie Side of the parking garage

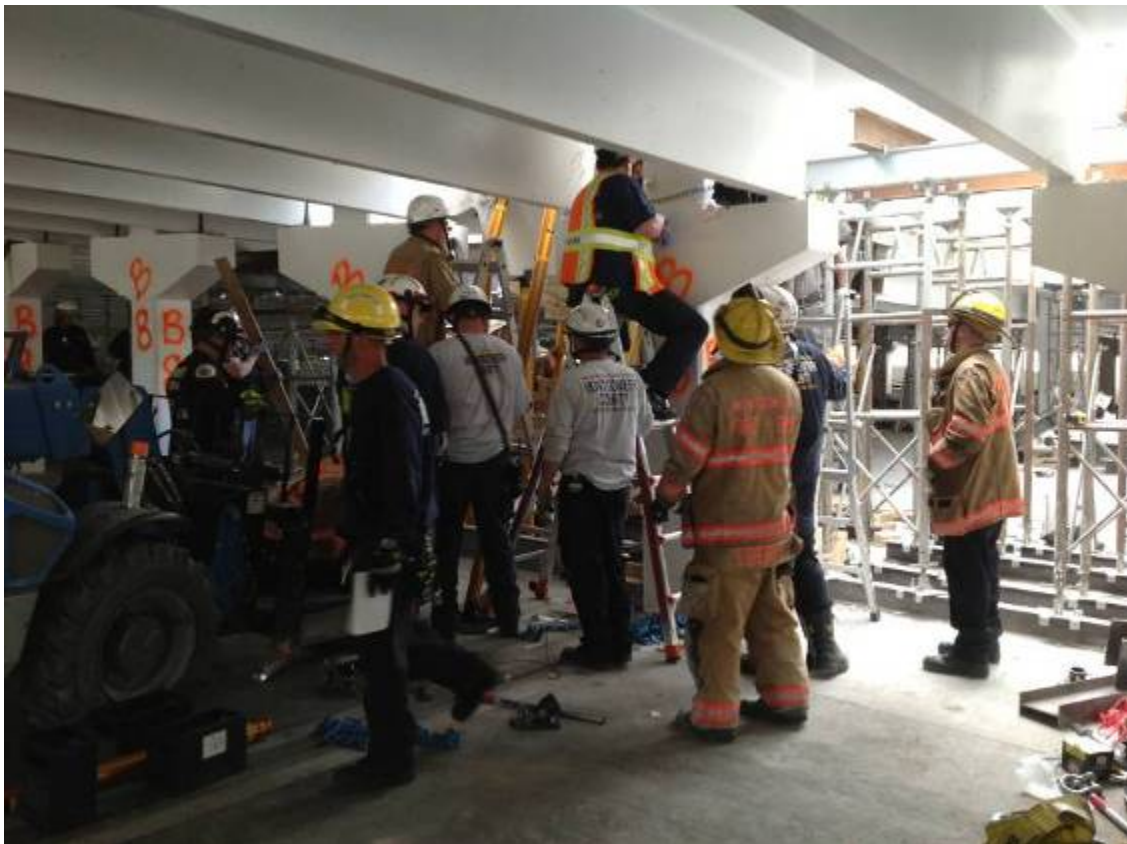
Figure 5 MCFRS TRT personnel put the shore assembly in place.

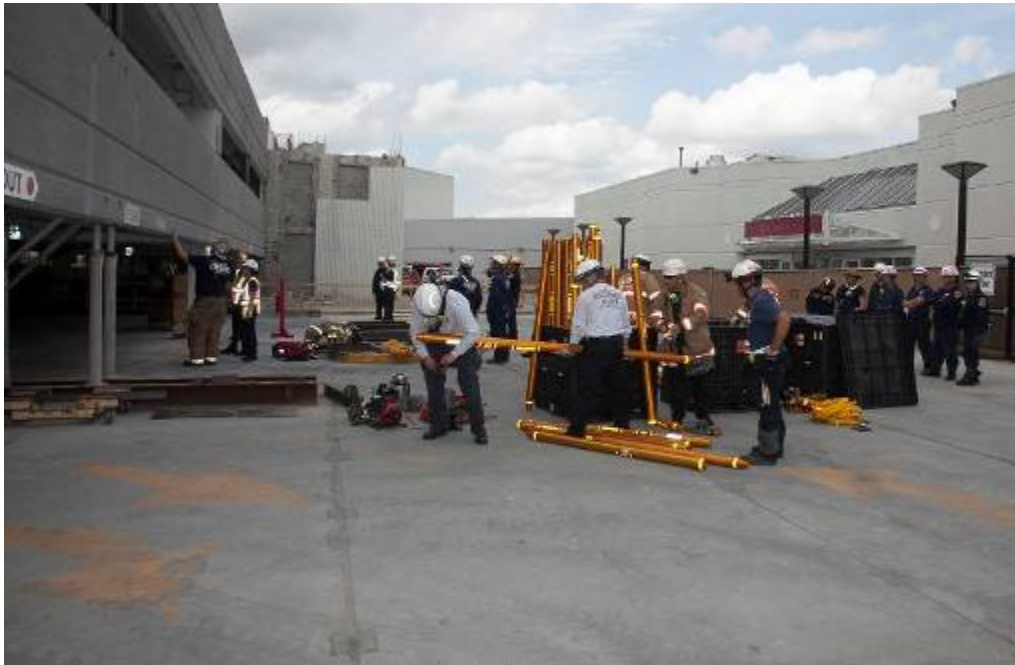
Figure 6 Crew completing the shoring set up from TRT Logistics.

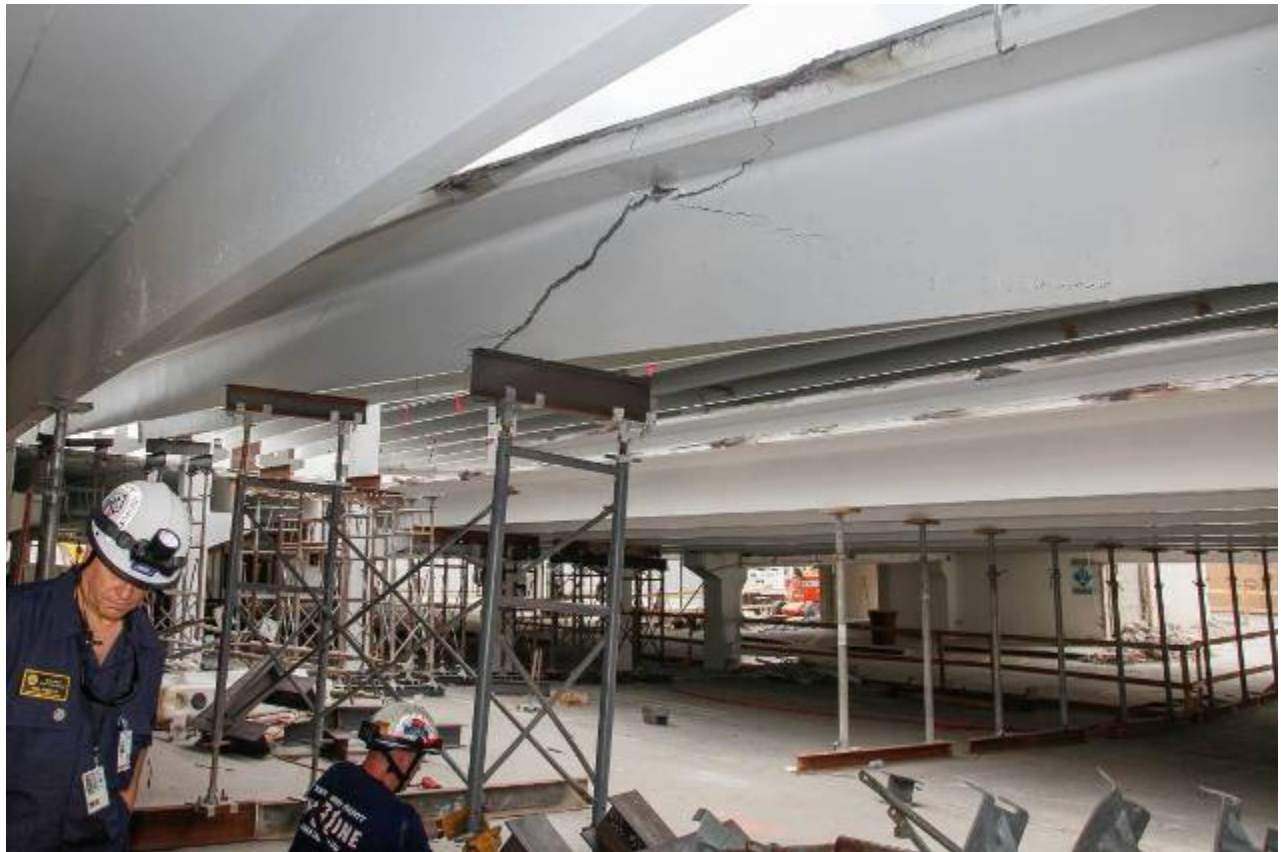
Figure 8 TRT Members assess and shore the interior area of the collapse
